Special Report 79-16

ROOF MOISTURE SURVEY— U.S. MILITARY ACADEMY

The roofs and upper story walls of buildings 745E, 752 and 756 at the U.S. Military Academy in West Point, New York, were surveyed for entrapped moisture with an AGA Thermovision 750 infrared camera on the nights of 17 and 18 April 1978. These multi-storied stone and masonry buildings are used for barracks and classrooms.

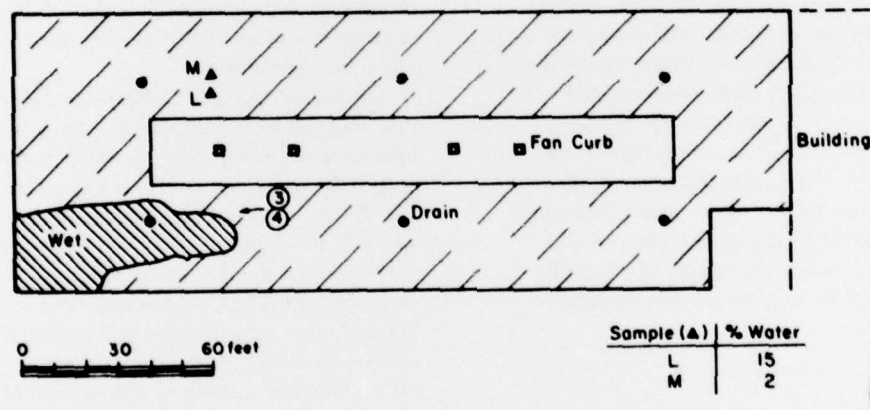
Core samples taken the following day in light and dark mottled areas indicated that the insulation in the light areas contained more moisture than that in dark areas. The water content from a light area (sample L, Fig. 2) was 15% and that from a dark area (sample M) was 2%. It is estimated that over half of the insulation in this roof contained about 15% moisture. Tests underway at CRREL suggest that the thermal resistance of urethane insulation is decreased by 5 to 10% when it contains 15% moisture by weight. Therefore, the thermal implications of this amount of moisture are minor. Removing such insulation cannot be justified by energy conservation alone.

Only one well-defined bright thermal anomaly was detected with the infrared camera. This anomaly is shown by the tight hatching in Figure 2. Figures 3 and 4 are, respectively, a thermogram and a daytime photograph of this area. This thermal anomaly was much more intense than the light mottled areas over most of the roof and thus a stronger indication of moisture. No samples were obtained from this area but it is felt that the insulation therein contains substantially more than 15% moisture by weight.

Figure 2. Plan view of Building 745E. The tight hatching indicates an area of entrapped moisture. The open hatching indicates that small amounts of moisture are randomly dispersed throughout the roof. The arrow and circled numbers indicate the viewing direction of Figures 3 and 4.

Once the source of moisture has been eliminated, it may be possible for moisture in the urethane insulation to dissipate by edge venting at the perimeter of the roof. Although little information or experience is available on the drying ability of urethane insulation, it is doubted that the single very wet area (tight hatching in Fig. 2) will dry in this fashion.

Normally it would be recommended that the membrane and insulation in the very wet area be removed and replaced with dry insulation and a new membrane. However, the entire membrane on this roof is blistered and probably will require replacement in a few years. Therefore, it is suggested that the wet urethane insulation remain in place until it becomes necessary to remove and replace the membrane and insulation over the entire roof.

To maximize the remaining useful life in the blistered membrane, foot traffic should be kept to a minimum and all flashings and penetrations, especially those within the wet area, should be periodically examined and, where necessary, patched to assure that no additional moisture enters the roof.

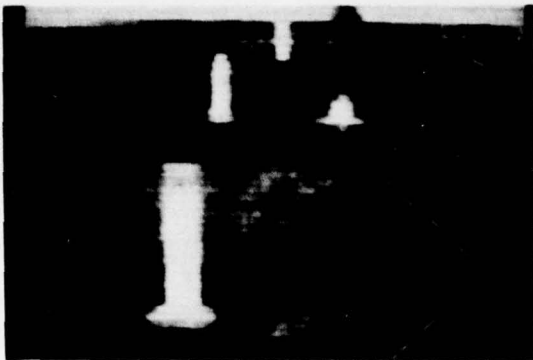
Figure 3. Thermogram of wet area in the southwest corner of building 745E. The dashed line approximates a portion of the boundary of the wet area painted on the roof.

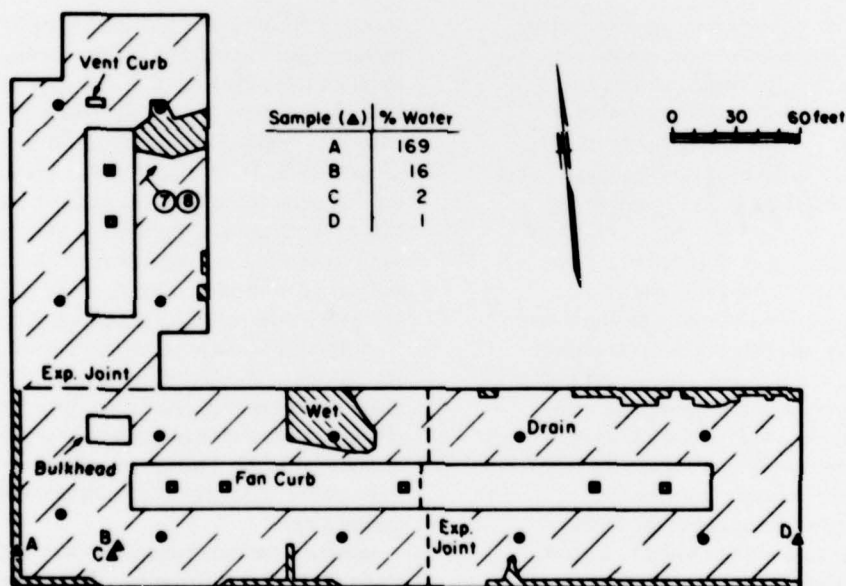
Figure 6. Plan view of building 756.

Figure 6 indicates that several well-defined wet areas were located all along the perimeter of this roof. Sample A, which had a water content of 169%, was taken from one typical wet area. Figures

Since it is expected that the membrane on this roof will have to be replaced in a few years, it is recommended that all the wet insulation remain in place until a new membrane is necessary. In the interim, all foot traffic should be minimized and periodic visual examinations should be conducted on this roof to locate and patch any moisture entry points.

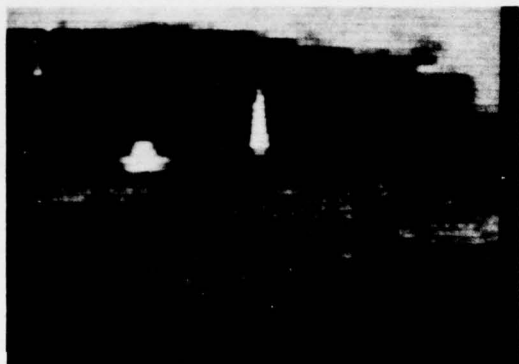
Figure 7. Thermogram of a wet area on Building 756.

7 and 8 are a thermogram and a photograph of another wet area.

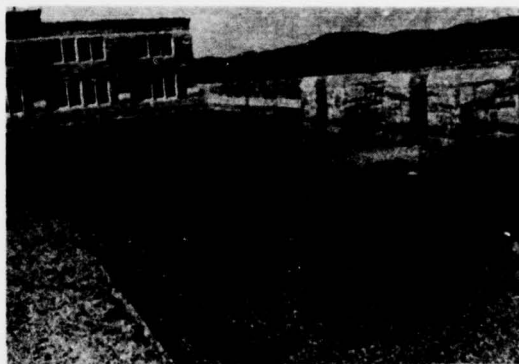
Figure 8. Photograph of the wet area shown in Figure 7.

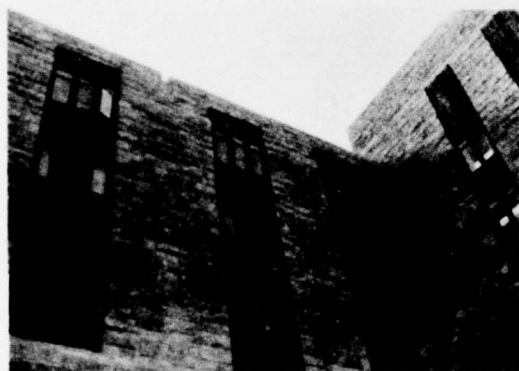
Figure 9. Windows of building 752 that protrude from the wall creating a flat, horizontal surface at the top of each window. Driving rain may enter there.

The window panels on this building protrude from the surface of the wall (Fig. 9). This creates a flat

horizontal surface at the top of the panel where rain water could temporarily collect and run into the building through voids in the panel-to-wall caulking joint. However, it is also possible that these leaks are caused by water which enters the spalled parapets, runs down the 3-in.-wide wall cavity onto the top of the windows and then into the building.

If leaks still persist at the windows after waterproofing the parapets, all window panel-to-wall joints should be examined and, if necessary, recaulked. If this fails to solve the problem, thought should be given to adding slope to the top of each window to direct rain water away from these areas.

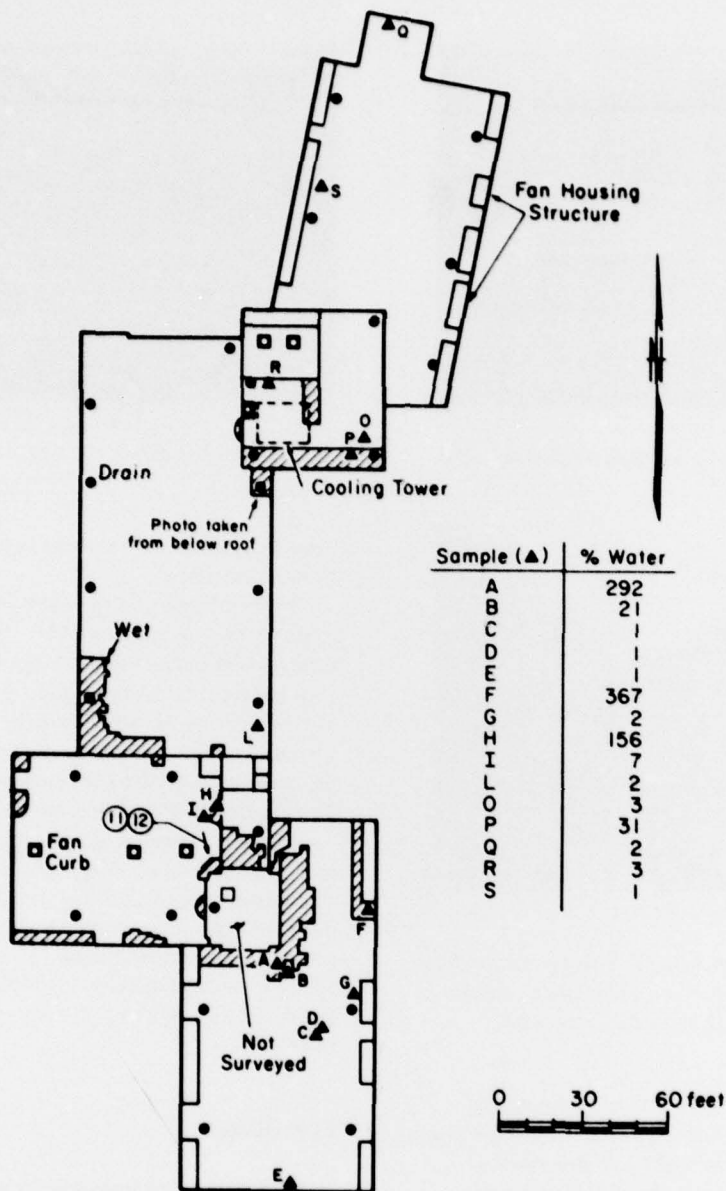
Figure 10. Plan view of building 752.

able to locate several areas suspected of containing wet insulation. Their boundaries were marked with white spray paint. Fifteen core samples were taken to verify the suspected moisture conditions. Their locations and water contents are shown in Figure 10. Samples E, G, L, and R revealed that the detected thermal anomalies surrounding these samples were not moisture-related but were caused by heat radiating from adjacent walls or heat from nearby exhaust fans. Consequently, the spray painted boundaries associated with samples E, G, L, and R are not shown in Figure 10. Of the remaining samples, those indicated as wet by the thermograms were confirmed to be wet and those indicated as dry were confirmed to be dry. Figures 11 and 12 show a typical thermogram and a photograph of a detected wet area.

As noted in Figure 10, a wet rectangular area surrounds a drain on the central roof of this building. During the daytime walk-through inspection it was pointed out that a portion of the carpet directly below this drain had been water stained. Water stains on the underside of the deck surrounding this drain pipe are shown in Figure 13. They suggest that water enters the building here through a defect in the roof membrane-to-drain seal.

The roof membrane appears to be in excellent condition. It is not blistered. However, entrapped moisture can cause a roof system to deteriorate rapidly. To achieve maximum life from this roof it is suggested that all wet insulation in the hatched areas in Figure 10 be cut out and replaced with dry insulation and built-up roofing. Care should be taken to assure that the membrane-to-drain seal for the problem drain shown in Figure 13 is made watertight.

The built-up membrane on building 752 is essentially free of blisters. Since entrapped moisture can shorten the useful life of a roof system, it is recommended that all wet areas shown in Figure 10 be cut out and replaced with dry insulation and a built-up membrane. If periodic visual inspections are conducted and any defects patched, many years of useful life should be obtained from this roof.

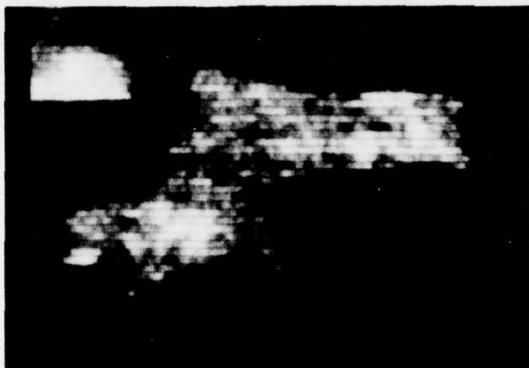
Figure 11. Thermogram of a wet area on building 752.

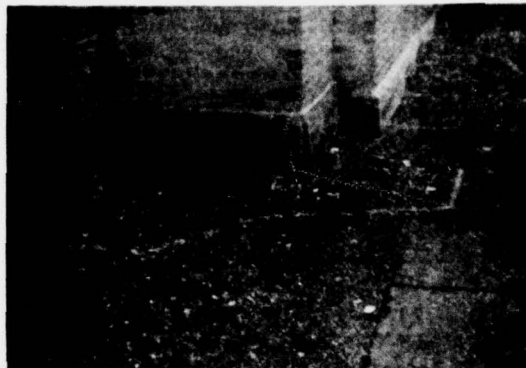
Figure 12. Photograph of the wet area shown in Figure 11.
